LAKE TISHOMINGO DAM
JEFFERSON COUNTY, MISSOURI
MISSOURI INVENTORY NO. 30039

PHASE I INSPECTION REPORT
NATIONAL DAM SAFETY PROGRAM

PREPARED BY: ST. LOUIS DISTRICT CORPS OF ENGINEERS
FOR: GOVERNOR OF MISSOURI

JANUARY 1978

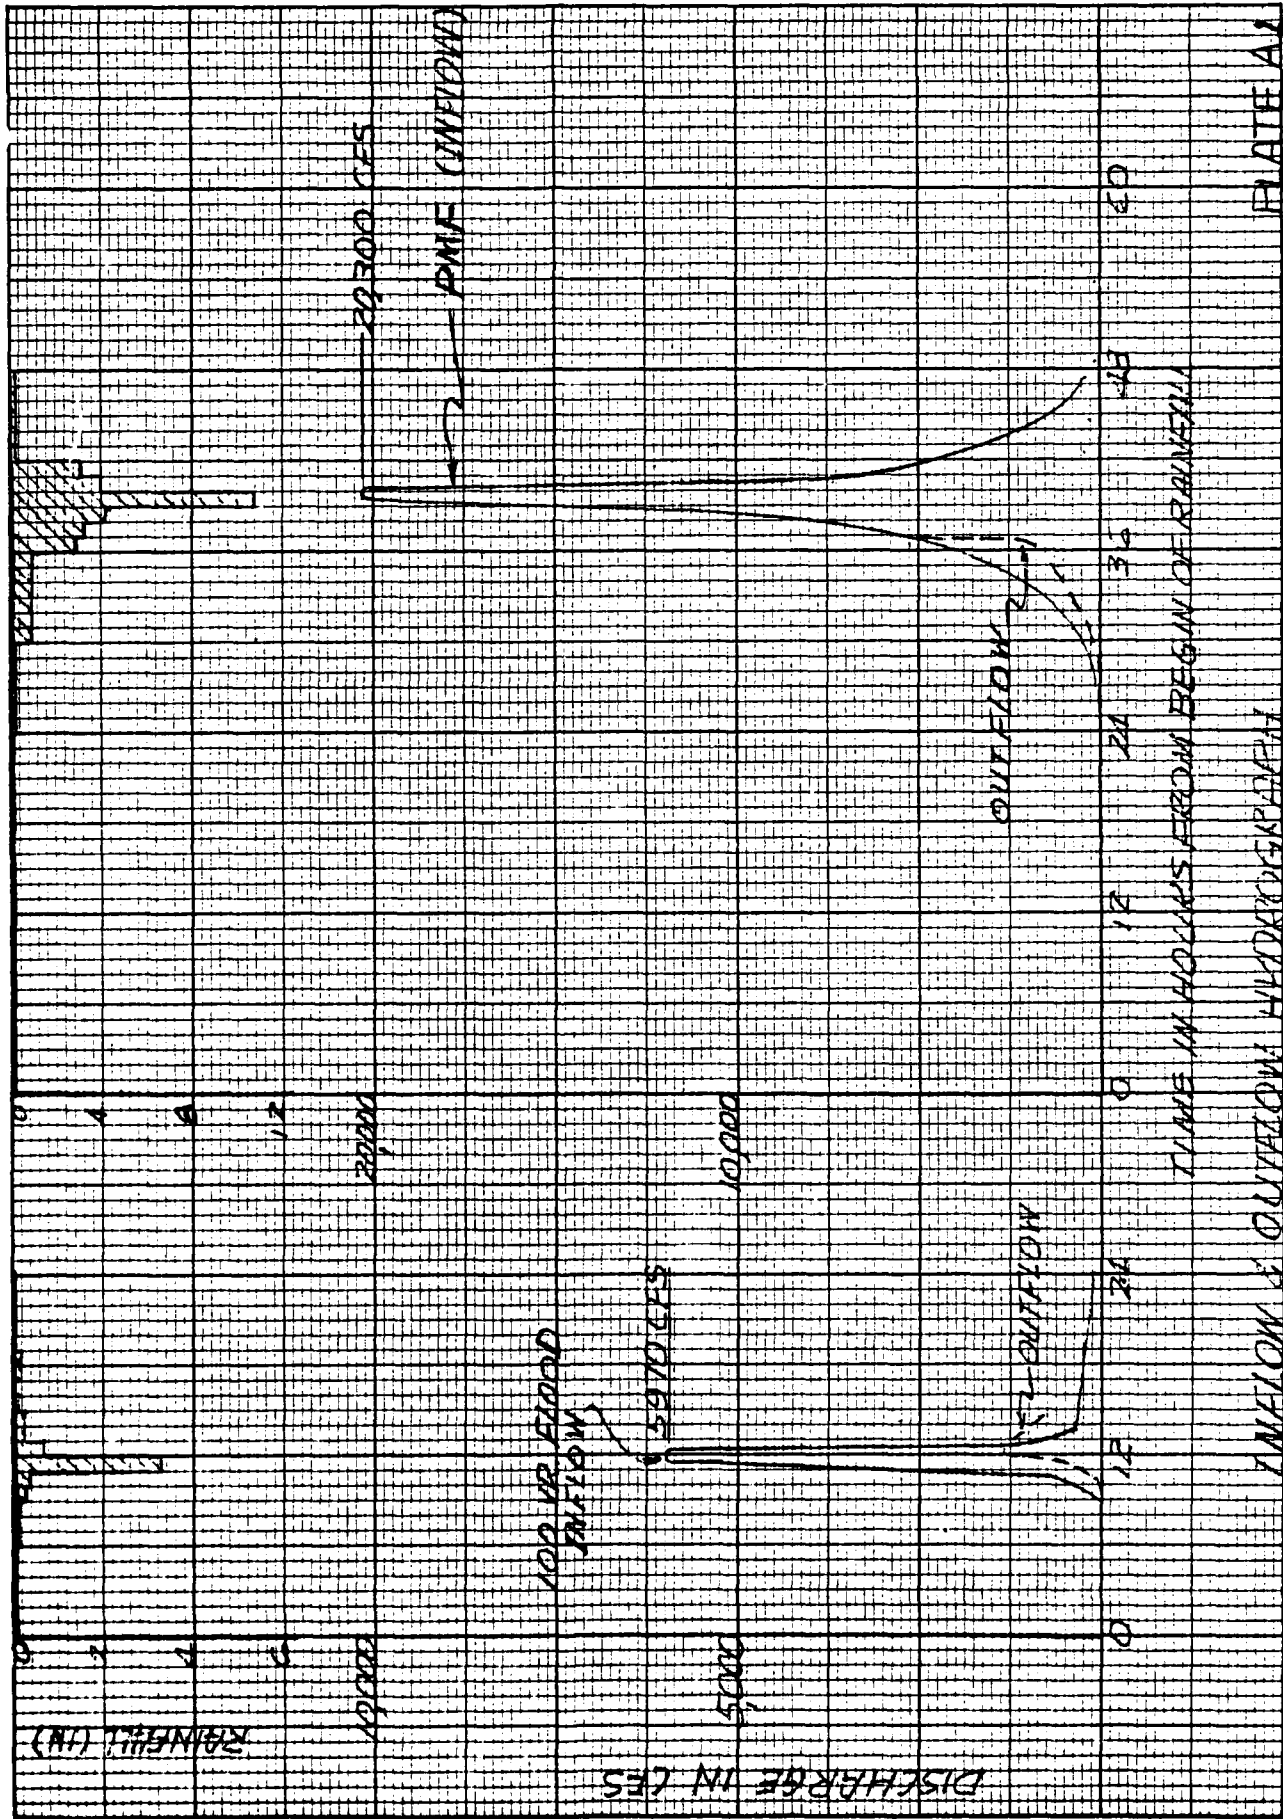
PLATE A1

d. Overtopping Potential. The spillway is too small to pass the minimum required flood of the probable maximum without overtopping. The probable maximum flood is defined as the flood discharge that may be expected from the most severe combination of critical meteorologic and hydrologic conditions that are reasonably possible in the region. The existing spillway will pass a 100-year frequency flood without overtopping. According to the recommended guidelines from the Department of the Army, Office of the Chief of Engineers, the 100-year frequency flood is only adequate for a low hazard dam of intermediate size.

a. Alternatives. Spillway size and/or height of dam should be increased to pass the probable maximum flood without overtopping the dam.

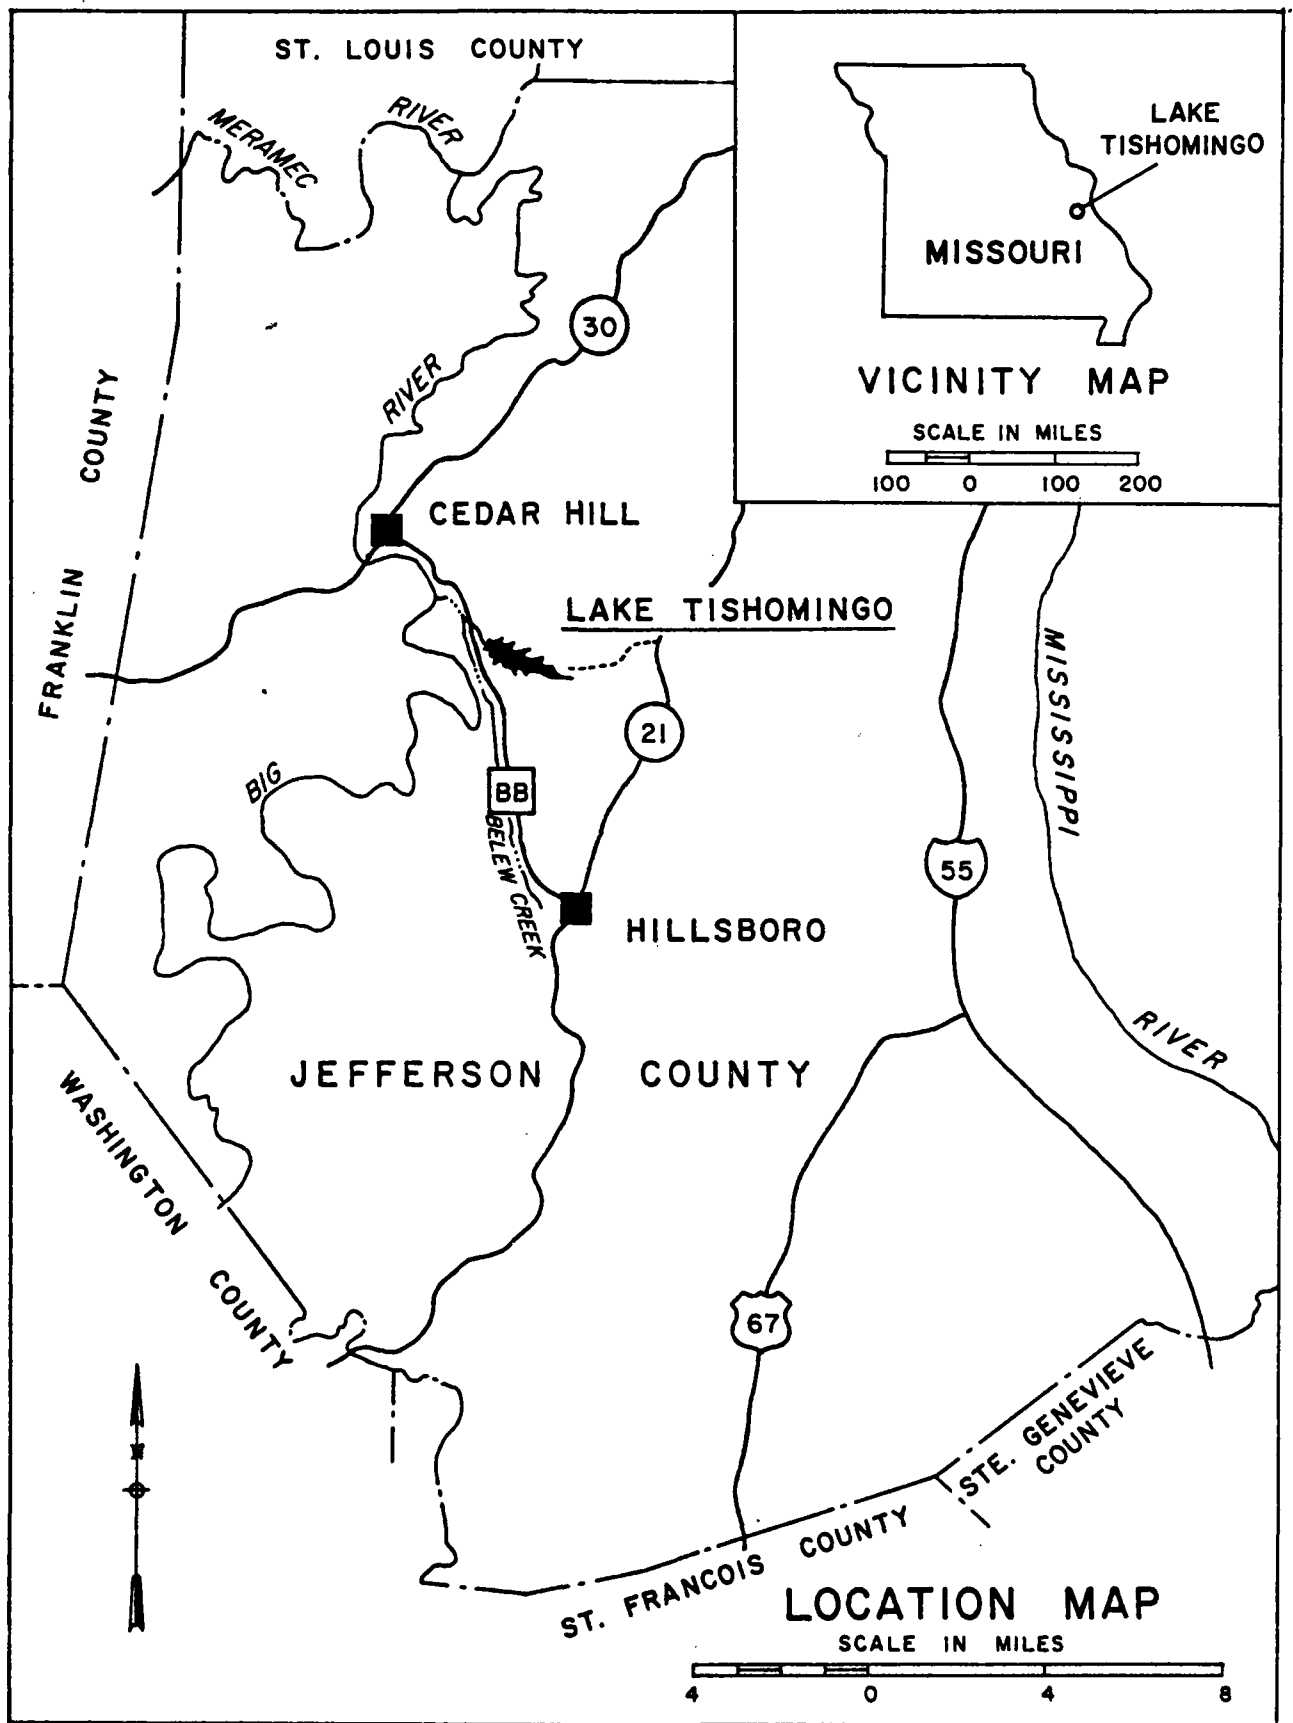
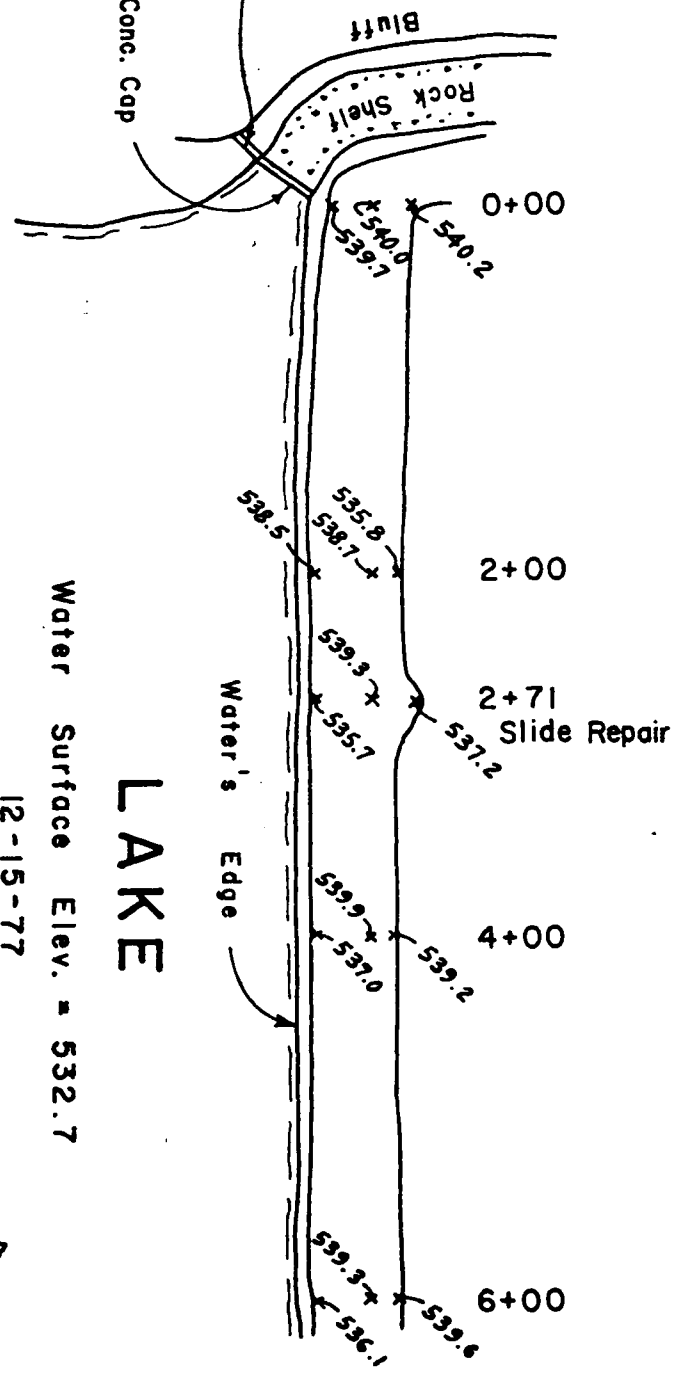
LAKE TISHOMINGO
 TOP OF DAM
 ELEVATIONS

(2) A spillway was cut in the Jefferson City dolomite on the left abutment (west end of dam). A plug approximately 20 feet long by 4 feet wide by 5 feet deep was recently excavated from the left side of the spillway to lower the lake for maintenance in the upper end of the lake. This excavation was replaced with earth. A small concrete cap was placed on a remaining portion of the rock spillway to prevent erosion (See Plate 3).

20' Rock Spillway with 4' Clay Plug
 30' Rock Spillway with Conc. Cap
 Crest Elev. = 532.1
